FILTERED FUME CABINET EXAMINATION REPORT

Customer Details										Safelab Engineer:		
Site		Address			Contact Name			Date:		27/03/2025		
Prince Philip Hospital		Line 1:	Day Surgery Unit			[REDACTED]			Previous Test Date:		09/04/2024	
		Line 2:	Bryngwyn Mawr						Job Number:		65593	
		Line 3:	Llanelli						SP Number:		5	
		Post Code:	SA14 8QF						Work Type:		Routine Test	
Room:		Theatre 1 Dirty Utility		Make:		Safelab		Application:		Non-School		
Site Asset #:		N/A		If Other:		N/A		Process:		Not Identified On Unit		
Model:		FC750		Serial:		8967/04/22		Hazard to be Controlled:		Fumes & Vapours		
Filter Details & Integrity Test Results												
Date Fitted	Type	Carbon Name	If Other	Size	Height	Width	Depth	Lot / Serial #	Test	Results		
03/05/2022	Carbon	CI-200		B100				211221-06	Carbon Alcohol Challenge Result:	PASS - No signs of breakthrough		
Airflow Assessment												
Face Velocity Grid (m/s)				Unit Aperture Width (mm):		700		Previous Airflow (m/s):		0.41

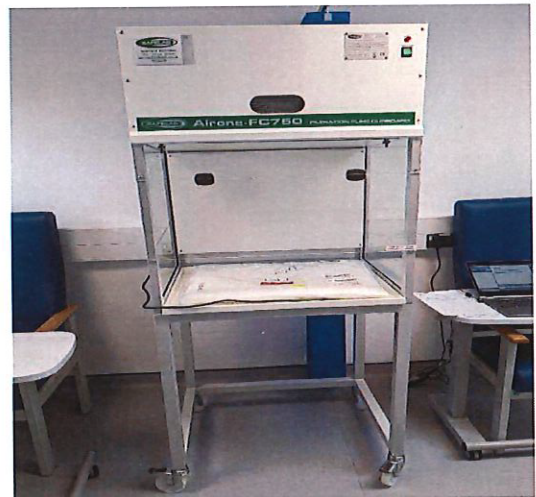
Photographs

Fume Cupboard Type FILTRATION

Model AIRONE R RS FC750 SIZE

Serial No. 8967/04/22 Year 2022

In accordance with BS 7989 : 2001

Volts 230 Hz 50
